**No:** 12/92

**Ref:** EW/G92/09/26

**Aircraft Type and Registration:** Boeing 737-3YO, G-MONM

**Location:** Luton Airport, Bedfordshire

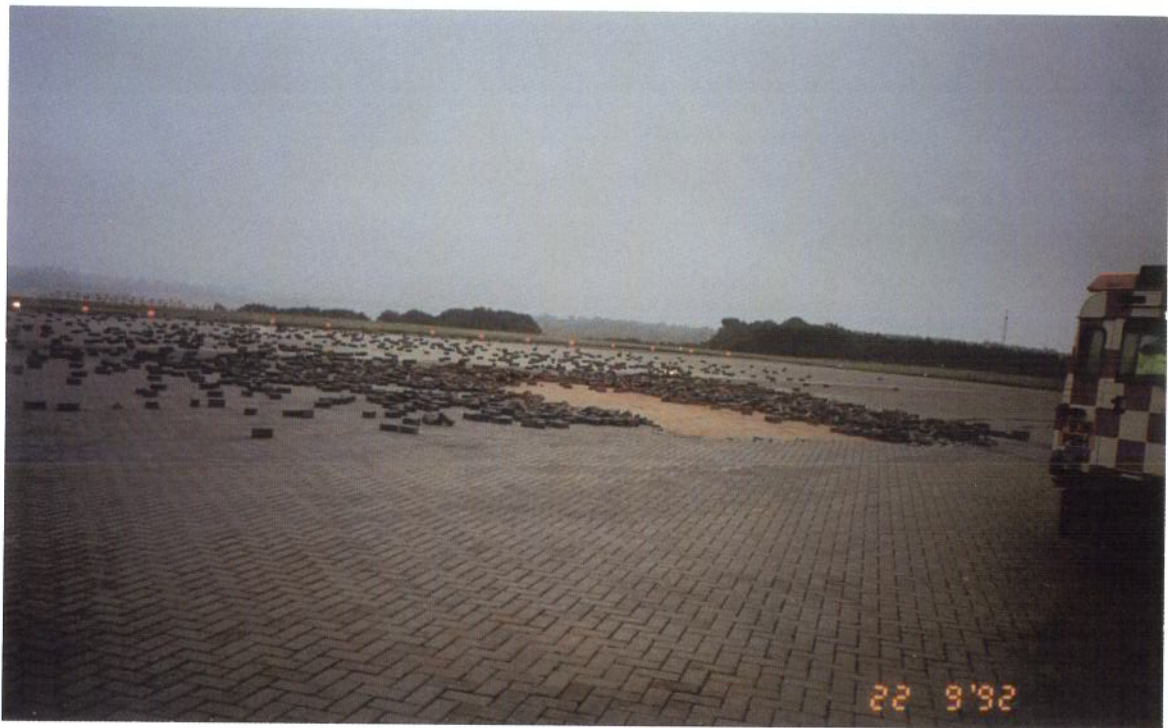
At 0801 hours, the next aircraft awaiting departure reported that a significant number of paving blocks were displaced from the turning circle at the threshold of Runway 26 (Figure 1). Inspection by the airport operations vehicles revealed that some 130 square metres of paving blocks had become displaced. As no previous departing aircraft had reported the damage to the surface, ATC considered that the aircraft most likely to be involved was the previous departure, G-MONM. London ATCC were asked to pass a message to the aircraft to contact the airline urgently.

A firm of consultant civil engineers was commissioned by the airport authority to investigate the damage to the surface, and produce recommendations for the avoidance of a recurrence. This report concluded that the *"most likely mode of failure of the pavement is that an area of low pressure, created immediately aft of the engine exhaust nozzle by the entrainment of free air by the jet blast stream, was of sufficiently low value to cause the pavement to lift, probably in a blister-like shape."*

**FIG 1. DAMAGE TO THE RUNWAY THRESHOLD TURNING CIRCLE**

As a result of the report, the airport authority requested the CAA to issue a NOTAM. This came into effect on 7 October 1992, announcing a temporary operational restriction on the use of the Runway turning circles, stating that they should be used only for aircraft manoeuvring at low engine power. Jet

aircraft with low slung engines are prohibited from commencing their take-off run from within the 85 metre turning circles. This NOTAM is valid until 31 December 1992, by which time the airport authority expects that contractors will have completely resurfaced the turning circles with Marshall Asphalt, after removing all the paver blocks and sand.

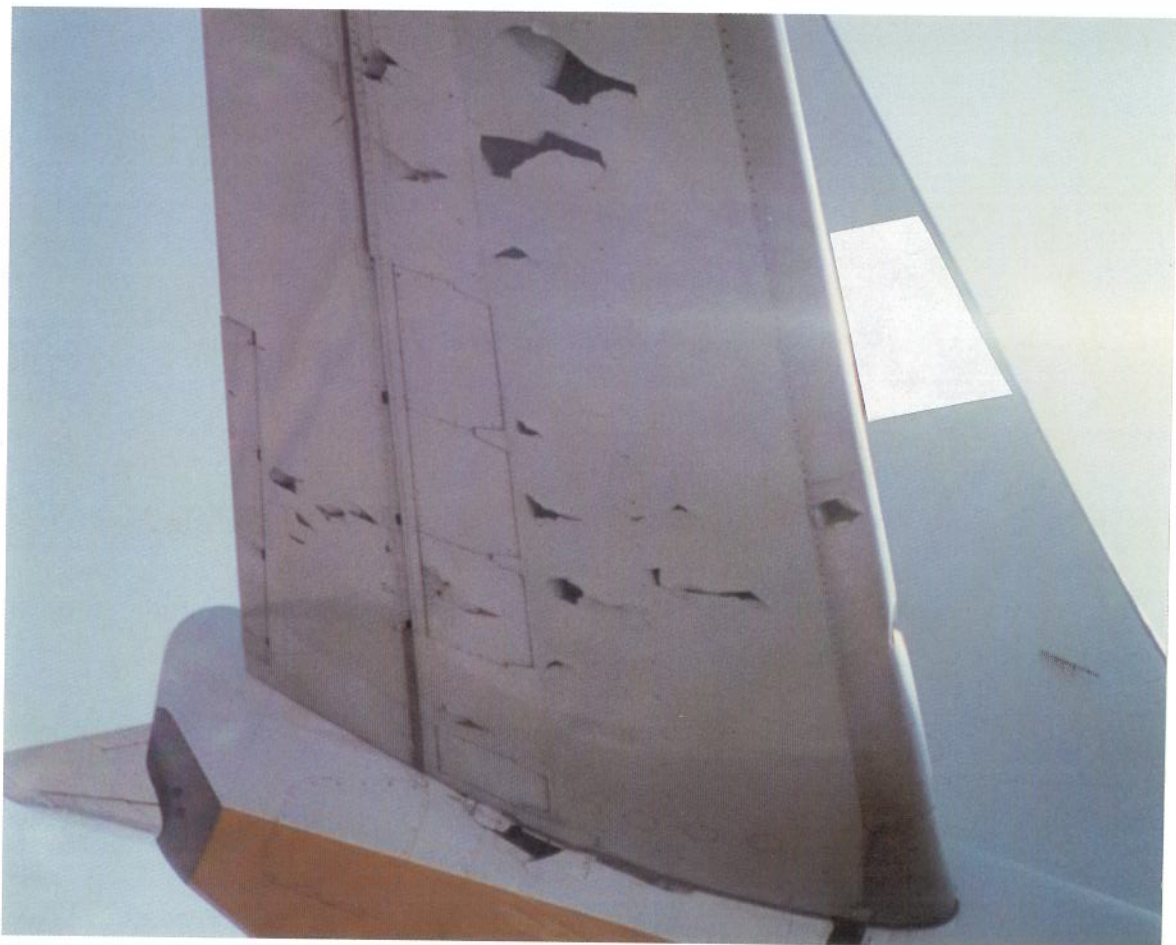
The damage to the aircraft (Figure 2) was observed by the crew during the turn-round inspection at Alicante, and the return flight was abandoned. The company were informed and, after consultation with the manufacturer, a working party was dispatched to make temporary repairs to the aircraft prior to its empty ferry flight back to the UK. The right hand stabilizer assembly and elevator were replaced after its return.

The damage consisted of some 18 holes in the underside skin of the right stabilizer, the largest measuring some 18 inches by 6 inches, and most having bent and jagged edges. Some damage to the internal rib structure was also apparent. The leading edge was dented, with a large hole below. The right elevator had several smaller holes in its skin.

**FIG 2. DAMAGE TO THE RIGHT STABILIZER AND ELEVATOR**
