Saito production engines tend to run weak and hotter on the upper (no1) cylinder then richer and cooler on no 2 & 3. There are many reports of cylinder bases cracking on no 2 & 3. considered to be caused by excess fuel ingestion and hydraulic locking in certain conditions.

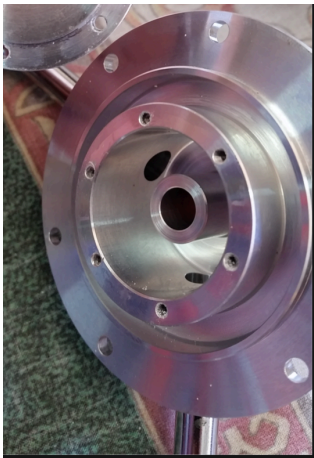
The factory fuel mixture distribution plenum can suffer from neat fuel “pooling” which can be ingested into one of the lower cylinders causing hydraulic lock. The following pic shows the radially drilled passages to the cylinders .
